**Ecological Reference Reach Site**

# 2011 Monitoring Summary

## Vaughn Creek at AL Hwy 10 in Choctaw County (32.11227/-88.13110)

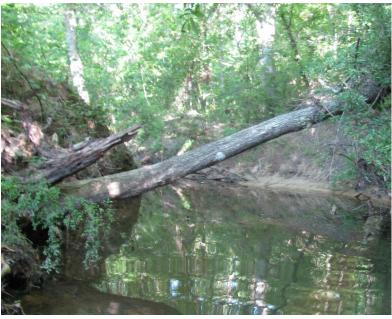
Figure 1. Vaughn Creek at VANC-1, May18, 2011.

General observations (Table 2) and a habitat assessment (Table 3) were completed during the macroinvertebrate assessment. In comparison with reference reaches in the same ecoregion, this information can give an indication of physical condition and the availability and quality of habitat. Vaughn Creek at VANC-1 (Figure 1) is a low-gradient stream with sand, gravel, and clay substrates. The stream is characterized by poor sinuosity, a narrow riparian zone and unstable banks made overall habitat quality as *marginal*.
